**Flood Control Project Maintenance  
Levee Inspections**

## Maintenance Issue Types Only, Levee Inspection Report By Mile - Spring 2017

### Reclamation District No. 2058 Pescadero

Waterway	Bank	Unit Miles	Inspection Start/End	Inspector
Unit No. 01 Paradise Cut	Left	6.58	04/19/2017 04/19/2017	Maksim Khashchuk

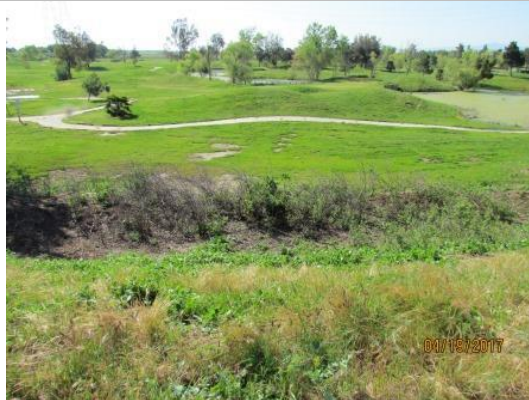
Photo 1 of 1 : SP\_2017\_RD2058\_111\_4\_20170421\_00042.jpg

LM Start	<b>0.23</b>	Rating **	M	Issue No.	<b>4</b>
LM End	<b>0.23</b>	Issue Type +	Ma	Location *	LS
Category	Earthen Levee		GPS Latitude/Longitude		
			Start	End	
Item	Vegetation		37.804351°	37.804351°	
			-121.418433°	-121.418433°	
DWR ID	DWR_RD2058_01_f_2013_4				
Comment Code					
V2 : Remove the wild growth other than native grasses from the levee slopes.					
Inspector Comment					
Wild rose on the levee. This area is riparian rabbit habitat.

View of the wild rose on the levee slope obstructing visibility and access.

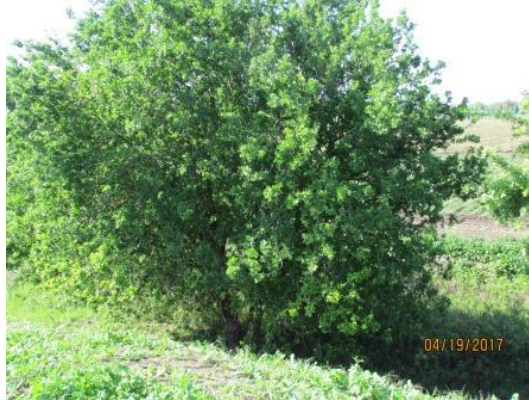
Photo 1 of 1 : SP\_2017\_RD2058\_111\_21\_20170421\_00043.jpg

LM Start	<b>0.55</b>	Rating **	M	Issue No.	<b>21</b>
LM End	<b>0.55</b>	Issue Type +	Ma	Location *	LS
Category	Earthen Levee		GPS Latitude/Longitude		
			Start	End	
Item	Trim / Thin Trees		37.802369°	37.802369°	
			-121.413902°	-121.413902°	
DWR ID	DWR_RD2058_01_s_2017_21				
Comment Code					
T1 : Trim trees to at least five feet above ground level.					
Inspector Comment

View of the tree that needs to be trimmed.

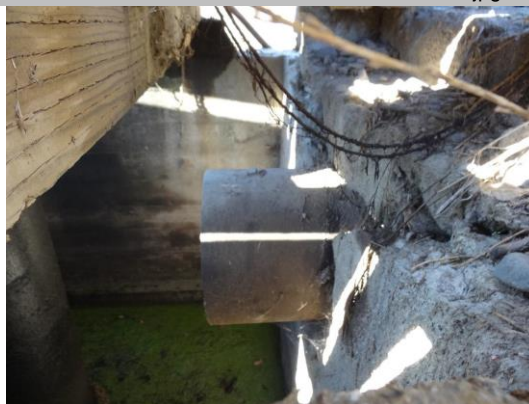
Photo 1 of 1 : UCIP\_SP\_2017\_45143\_45168.jpg

LM Start	0.72	Rating **	A/W	Issue No.	976
LM End	0.72	Issue Type +	Ma	Location *	LS
Category	Supplemental			GPS Latitude/Longitude	
				Start	End
Item	DWR UCIP LMA Responsibility			37.801792 °	37.801792 °
				-121.410921 °	-121.410921 °
DWR ID					
Comment Code					
Inspector Comment					
FS_ID:45143 DS_ID:22704 EP_NO: N/A Repair Type: No Action Needed Crossing Status: Found UCIP Comments: FIELD_STRUCT_DESC: *Abandoned* 12-inch pipe 18.0 feet below crown. Flap gate on waterward side. Pump on landward side. Grouted in place under Permit No. 5055. Originally included in the 1964 O&M manual, SJR 10, March 1964. FS Date: 5/12/2015

LS view: an abandoned pipe found in concrete sump.

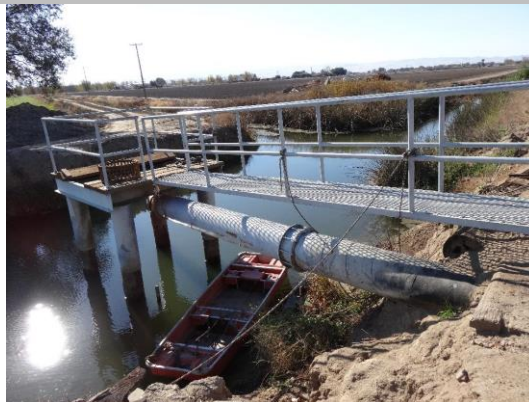
Photo 2 of 3 : UCIP\_SP\_2017\_51161\_45170.jpg

FS\_ID:51161  
DS\_ID:22694  
EP\_NO: 11546  
Repair Type: Urgent  
Crossing Status: Found  
UCIP Comments: 11/29/2016 Heavy erosion still present. Could be due to wave run-up as this is the only spot on levee not rock revetted. Greg Pombo (RD2058) indicated permits for endangered species prevent rock revetment. (K. Fazel - UCIP)05/12/2015 Erosion on west side of pipe at W/S toe. (K. Fazel - UCIP)  
FIELD\_STRUCT\_DESC: 18-inch steel drainage pipe through the levee, 2 feet below the crown. Pump in ditch on the landside (LS). Siphon breaker with cover on waterside (WS) shoulder. Electrical service pole at the LS toe. (Permit No. 11546, 1976 - Reclamation District 2058).  
FS Date: 11/29/2016

LS view: pipe, pile structure, and pump platform in drain ditch.

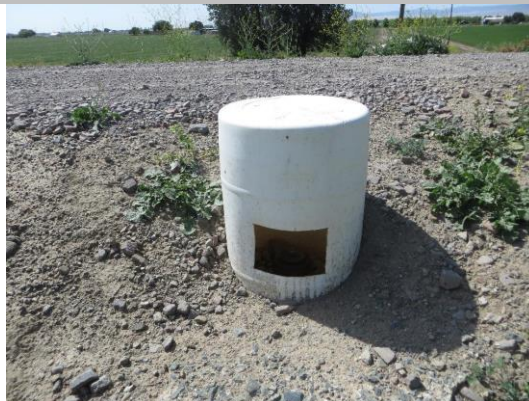
Photo 3 of 3 : UCIP\_SP\_2017\_51161\_74320.jpg

Comment Code					
Inspector Comment					
FS_ID:51161 DS_ID:22694 EP_NO: 11546 Repair Type: Urgent Crossing Status: Found UCIP Comments: 11/29/2016 Heavy erosion still present. Could be due to wave run-up as this is the only spot on levee not rock revetted. Greg Pombo (RD2058) indicated permits for endangered species prevent rock revetment. (K. Fazel - UCIP)05/12/2015 Erosion on west side of pipe at W/S toe. (K. Fazel - UCIP) FIELD_STRUCT_DESC: 18-inch steel drainage pipe through the levee, 2 feet below the crown. Pump in ditch on the landside (LS). Siphon breaker with cover on waterside (WS) shoulder. Electrical service pole at the LS toe. (Permit No. 11546, 1976 - Reclamation District 2058). FS Date: 11/29/2016

Siphon Breaker on WS shoulder.

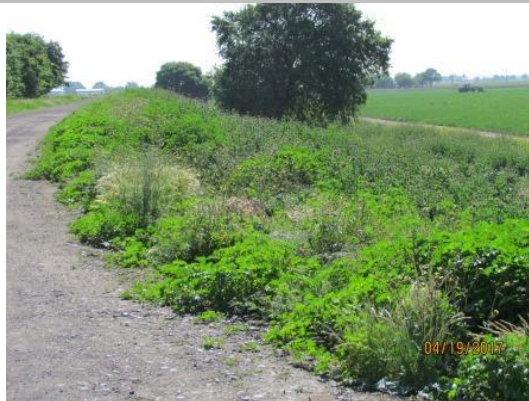
Photo 1 of 1 : SP\_2017\_RD2058\_111\_24\_20170421\_00044.jpg

LM Start	1.24	Rating **	M	Issue No.	24
LM End	2.11	Issue Type +	Ma	Location *	LS
Category	Earthen Levee			GPS Latitude/Longitude	
				Start	End
Item	Vegetation			37.802341 °	37.803914 °
				-121.401752 °	-121.386402 °
DWR ID	DWR_RD2058_01_s_2017_24				
Comment Code					
V1 : Control annual grass and weeds on the levee slopes and easements.					
Inspector Comment

View of the vegetation on the levee slope.

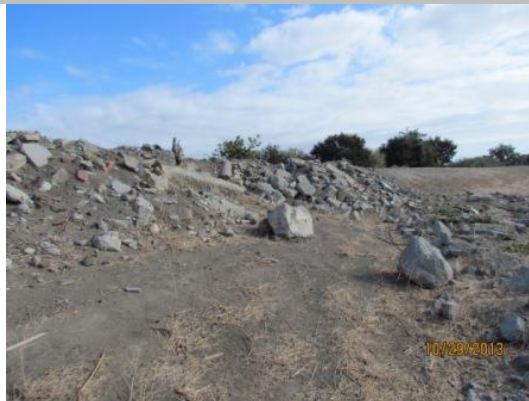
Photo 1 of 1 : SP\_2017\_RD2058\_111\_11\_20170407\_00005.jpg

LM Start	1.82	Rating **	U	Issue No.	11
LM End	1.83	Issue Type +	Ma	Location *	LS
Category	Earthen Levee			GPS Latitude/Longitude	
				Start	End
Item	Encroachments			37.804785 °	37.804802 °
				-121.391524 °	-121.391304 °
DWR ID	DWR_RD2058_01_f_2013_11				
Comment Code					
MA : Material					
Inspector Comment					
Pile of concrete contains rebar on landside slope obstructing visibility and access.

View of the concrete with rebar placed on the landside slope.

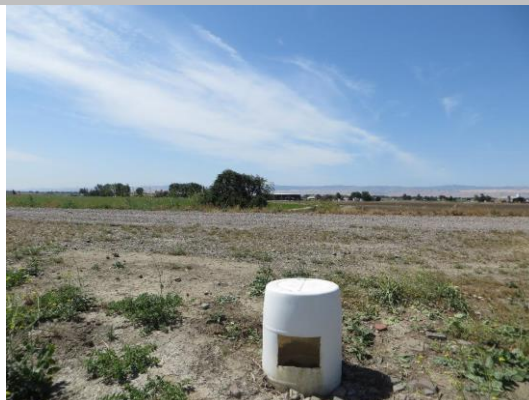
Photo 1 of 3 : UCIP\_SP\_2017\_45865\_74323.jpg

LM Start	2.12	Rating **	A/W	Issue No.	979
LM End	2.12	Issue Type +	Ma	Location *	LS
Category	Supplemental			GPS Latitude/Longitude	
				Start	End
Item	DWR UCIP LMA Responsibility			37.803892 °	37.803892 °
				-121.386299 °	-121.386299 °
DWR ID					
Comment Code					
Inspector Comment					
FS_ID:45865 DS_ID:22705 EP_NO: N/A Repair Type: No Action Needed Crossing Status: Found UCIP Comments: FIELD_STRUCT_DESC: 20-inch steel stormdrain pipe 8.0 feet below crown. Siphon breaker on waterside. Pump on concrete sump in drain ditch on LS toe. Originally included in the 1964 O&M manual, SJR 10, March 1964. FS Date: 5/12/2015

Siphon breaker on WS shoulder inside protective riser.

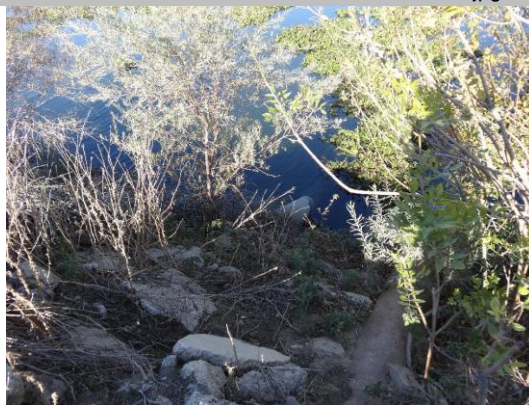
Photo 2 of 3 : UCIP\_SP\_2017\_45865\_74324.jpg

LM Start	2.12	Rating **	A/W	Issue No.	979 (cont)
LM End	2.12	Issue Type +	Ma	Location *	LS
Category	Supplemental			GPS Latitude/Longitude	
				Start	End
Item	DWR UCIP LMA Responsibility			37.803892 °	37.803892 °
				-121.386299 °	-121.386299 °
DWR ID					
Comment Code					
Inspector Comment					
FS_ID:45865 DS_ID:22705 EP_NO: N/A Repair Type: No Action Needed Crossing Status: Found UCIP Comments: FIELD_STRUCT_DESC: 20-inch steel stormdrain pipe 8.0 feet below crown. Siphon breaker on waterside. Pump on concrete sump in drain ditch on LS toe. Originally included in the 1964 O&M manual, SJR 10, March 1964. FS Date: 5/12/2015

Pipe just visible at WS toe at center of photograph.

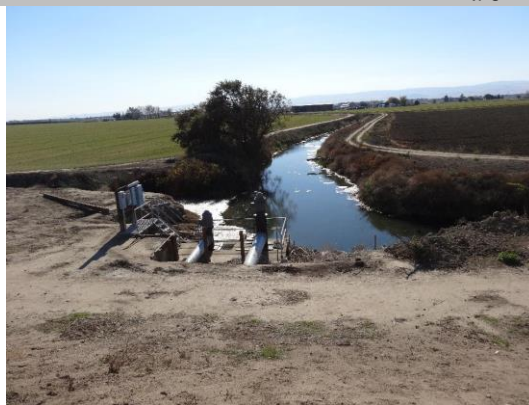
Photo 3 of 3 : UCIP\_SP\_2017\_45865\_74325.jpg

Pump on concrete pad at LS toe.

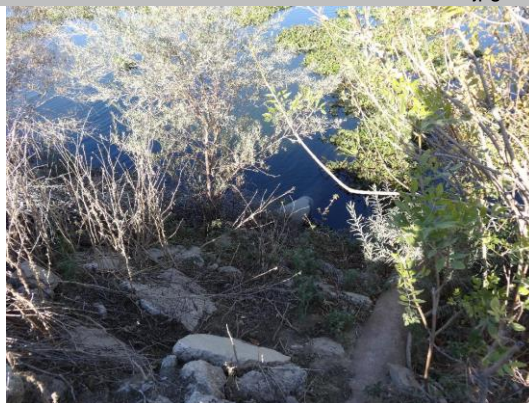
Photo 1 of 3 : UCIP\_SP\_2017\_51699\_45192.jpg

LM Start	2.12	Rating **	M	Issue No.	980
LM End	2.12	Issue Type +	Ma	Location *	LS
Category	Supplemental			GPS Latitude/Longitude	
				Start	End
Item	DWR UCIP LMA Responsibility			37.803886 °	37.803886 °
				-121.386271 °	-121.386271 °
DWR ID					
Comment Code					
Inspector Comment					
FS_ID:51699					
DS_ID:22706					
EP_NO: N/A					
Repair Type: Non-Urgent					
Crossing Status: Found					
UCIP Comments: Leaky and damaged siphon breaker on waterside shoulder..					
FIELD_STRUCT_DESC: 16-inch steel stormdrain pipe 8.0-feet below the crown. Siphon Breaker on waterward shoulder. Pump on concrete sump on landside. Originally included in the 1964 O&M manual, SJR 10, March 1964.					
FS Date: 5/13/2015

WS view: exposed steel pipe (right) on channel bank.

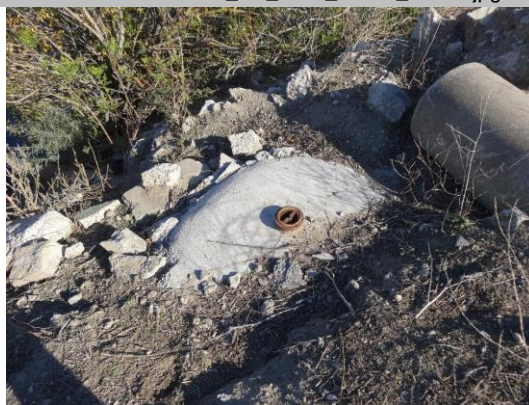
Photo 2 of 3 : UCIP\_SP\_2017\_51699\_45191.jpg

WS view: siphon breaker on concrete pad on levee slope.

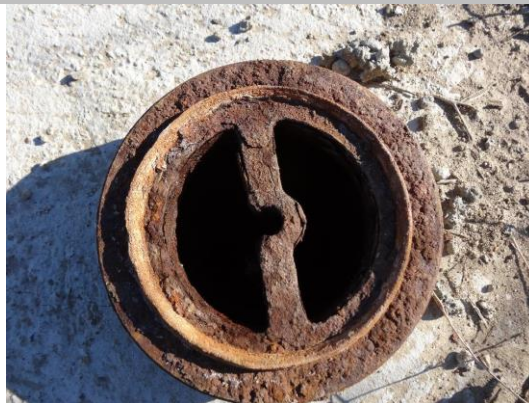
Photo 3 of 3 : UCIP\_SP\_2017\_51699\_45190.jpg

LM Start	2.12	Rating **	M	Issue No.	980 (cont)	
LM End	2.12	Issue Type +	Ma	Location *	LS	
Category	Supplemental			GPS Latitude/Longitude		
				Start	End	
Item	DWR UCIP LMA Responsibility			37.803886 °	37.803886 °	
				-121.386271 °	-121.386271 °	
DWR ID						
Comment Code						
Inspector Comment						
FS_ID:51699						
DS_ID:22706						
EP_NO: N/A						
Repair Type: Non-Urgent						
Crossing Status: Found						
UCIP Comments: Leaky and damaged siphon breaker on waterside shoulder..						
FIELD_STRUCT_DESC: 16-inch steel stormdrain pipe 8.0-feet below the crown. Siphon Breaker on waterward shoulder. Pump on concrete sump on landside. Originally included in the 1964 O&M manual, SJR 10, March 1964.						
FS Date: 5/13/2015

WS view: Upper part of the siphon breaker missing.

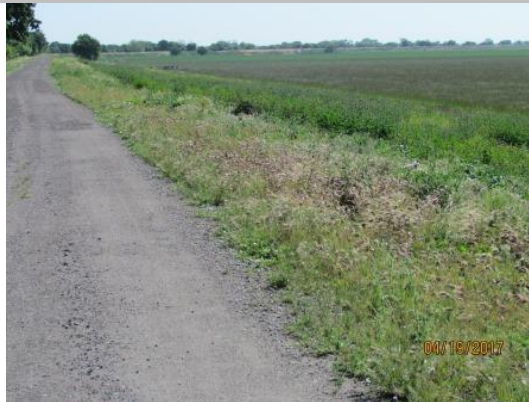
Photo 1 of 1 : SP\_2017\_RD2058\_111\_31\_20170421\_00045.jpg

LM Start	2.28	Rating **	M	Issue No.	31
LM End	2.94	Issue Type +	Ma	Location *	LS
Category	Earthen Levee			GPS Latitude/Longitude	
				Start	End
Item	Vegetation			37.803192 °	37.800534 °
				-121.383407 °	-121.371755 °
DWR ID	DWR_RD2058_01_s_2017_31				
Comment Code					
V1 : Control annual grass and weeds on the levee slopes and easements.					
Inspector Comment

View of the vegetation on the levee slope.

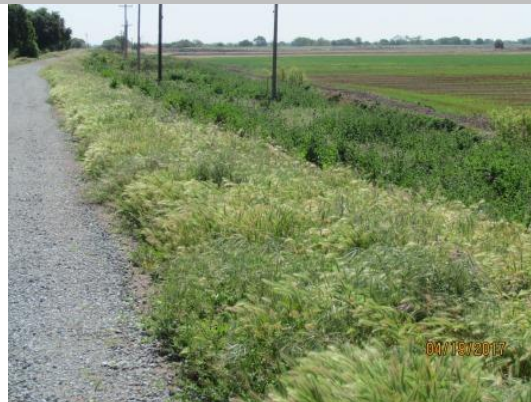
Photo 1 of 1 : SP\_2017\_RD2058\_111\_32\_20170421\_00046.jpg

LM Start	4.16	Rating **	M	Issue No.	32
LM End	5.31	Issue Type +	Ma	Location *	LS
Category	Earthen Levee			GPS Latitude/Longitude	
				Start	End
Item	Vegetation			37.789087 °	37.782311 °
				-121.357520 °	-121.341965 °
DWR ID	DWR_RD2058_01_s _ 2017_32				
Comment Code					
V1 : Control annual grass and weeds on the levee slopes and easements.					
Inspector Comment

View of the vegetation on the levee slope.

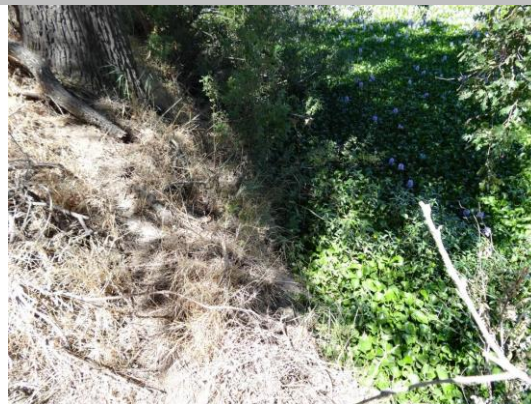
Photo 1 of 3 : SP\_2017\_RD2058\_111\_1\_20170407\_00001.jpg

LM Start	4.43	Rating **	M	Issue No.	1
LM End	4.47	Issue Type +	Ma	Location *	WS
Category	Supplemental			GPS Latitude/Longitude	
				Start	End
Item	DWR Erosion Survey			37.789810 °	37.789810 °
				-121.352490 °	-121.352490 °
DWR ID	DWR_RD2058_01_s_2017_1

Comment Code					
Inspector Comment					
07/20/2016: No significant change observed.					
08/04/2015: No significant change observed.					
08/26/2014: No significant change observed.					
08/28/2013: No significant change observed.					
07/26/2012: The site has been visited, and no significant change has been observed.					
09/02/2011: This site was not visited due to the time limit.					
09/22/2010: No significant change observed. Minor pocket erosions are lined at the lower bank. Two large Oak and Willow trees are on mid-slope and bench. The remaining bench was re-measured and found to be approximately 10 feet. There was no indication of active erosion on site during the site visit.					
08/05/2010: Recommended for annual assessment and monitoring of the site during flood events, per CLRO.					
07/23/2009: No major change observed since last visit; site is a 200-ft. long near-vertical berm erosion; recommend annual assessment and monitoring of the erosion site, per CLRO CES Evaluation 2008 Report; Site # is the same site previously reported as RM4.0,LM4.51; previously rated "U".

09/10/2008: Two large trees (2-3' DBH) with partial roots exposed.					
2007: Visited site 03/13/2007. [2016 Site ID:RD2058U01RM3.97]

Direct view of the pocket erosion site.

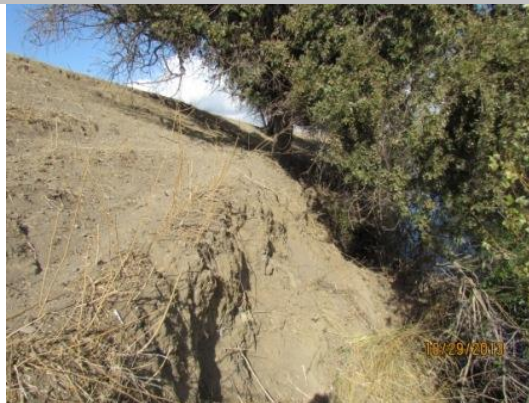
Photo 1 of 1 : SP\_2017\_RD2058\_111\_15\_20170407\_00007.jpg

LM Start	4.77	Rating **	U	Issue No.	15
LM End	4.77	Issue Type +	Ma	Location *	WS
Category	Earthen Levee			GPS Latitude/Longitude	
				Start	End
Item	Erosion / Bank Caving			37.785862 °	37.785862 °
				-121.350303 °	-121.350303 °
DWR ID	DWR_RD2058_01_f_2013_15				
Comment Code					
E1 : Note and monitor erosion site.					
Inspector Comment					
The erosion has about a 3 foot vertical cut at the waterside levee toe.

View of the erosion at the waterside levee toe.

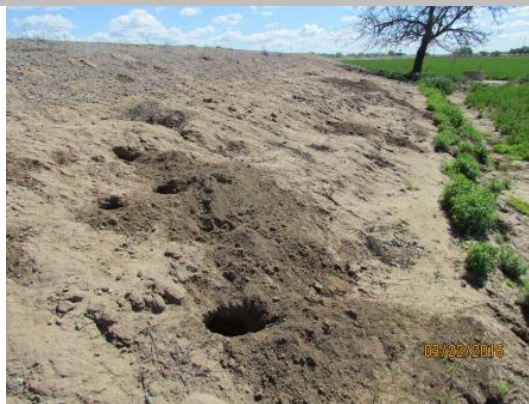
Photo 1 of 1 : SP\_2017\_RD2058\_111\_27\_20170407\_00011.jpg

LM Start	6.09	Rating **	A/W	Issue No.	27
LM End	6.10	Issue Type +	Ma	Location *	LS
Category	Earthen Levee			GPS Latitude/Longitude	
				Start	End
Item	Animal Control			37.773629 °	37.773503 °
				-121.333688 °	-121.333550 °
DWR ID	DWR_RD2058_01_s_2016_27				
Comment Code					
A3 : No rodents visible, but rodent burrows visible; need to backfill and compact or grout burrows.					
Inspector Comment					
LMA backfilled the rodent holes.

View of the rodent burrows on the landside levee slope.

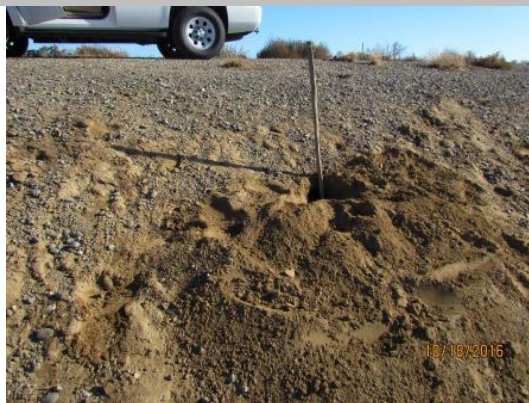
Photo 1 of 1 : SP\_2017\_RD2058\_111\_23\_20170407\_00010.jpg

LM Start	6.15	Rating **	M	Issue No.	23
LM End	6.15	Issue Type +	Ma	Location *	LS
Category	Earthen Levee			GPS Latitude/Longitude	
				Start	End
Item	Animal Control			37.773124 °	37.773124 °
				-121.332850 °	-121.332850 °
DWR ID	DWR_RD2058_01_f_2016_23				
Comment Code					
A3 : No rodents visible, but rodent burrows visible; need to backfill and compact or grout burrows.					
Inspector Comment

View of the rodent hole on the landside levee slope.
